Honda 225 Intake Air Bypass (IAB)

BF 225 IAB Maintenance Item not in the Helm Shop manual

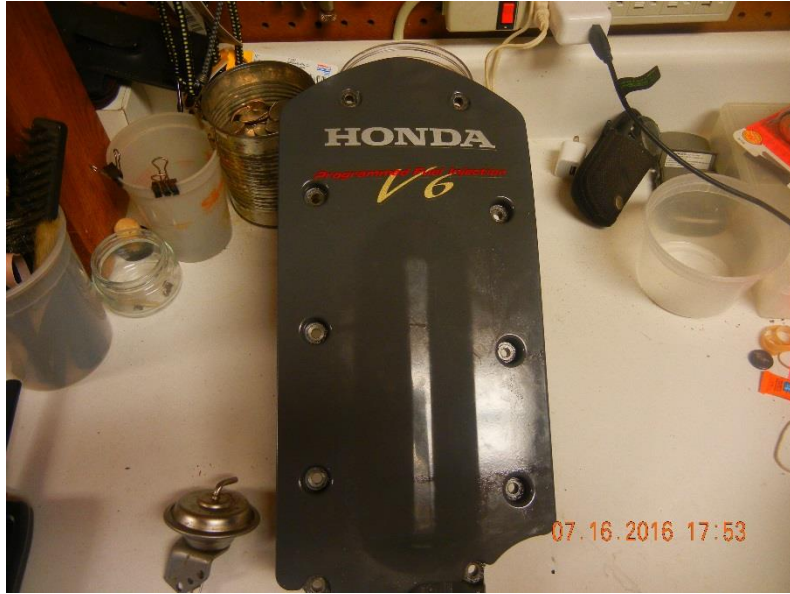
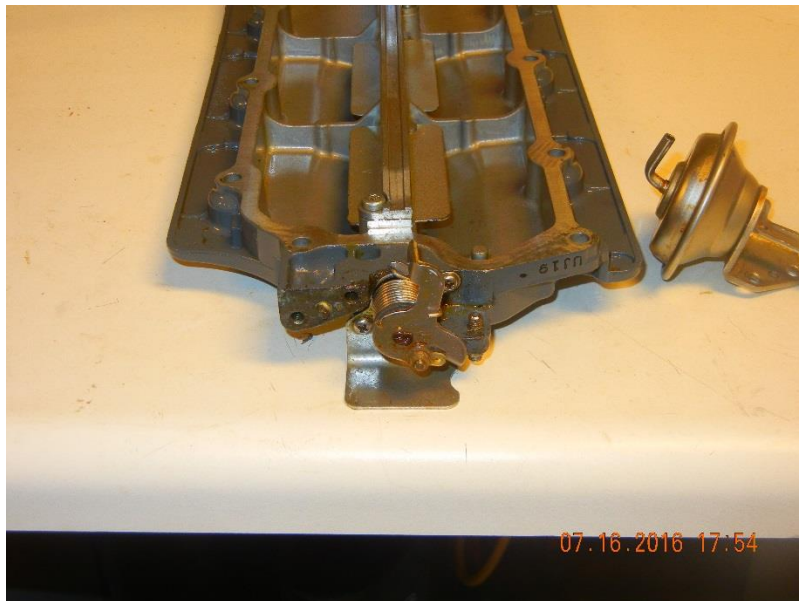
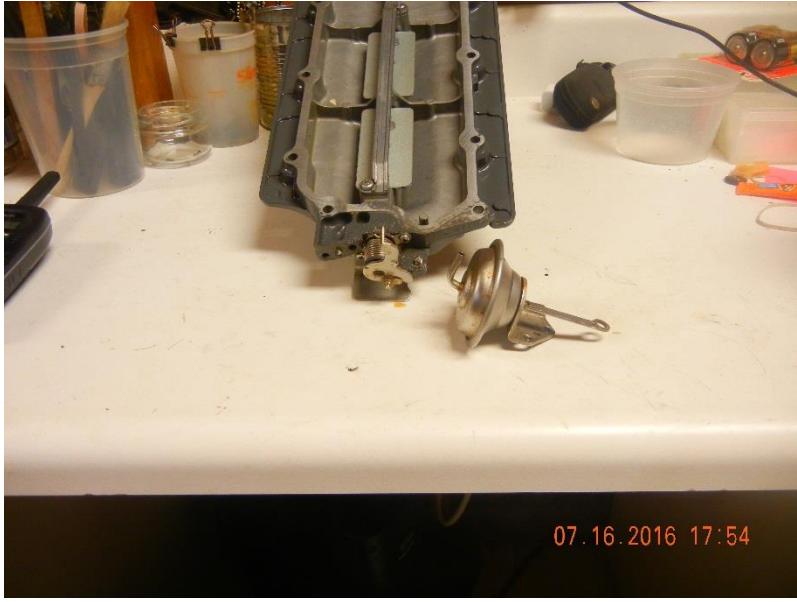
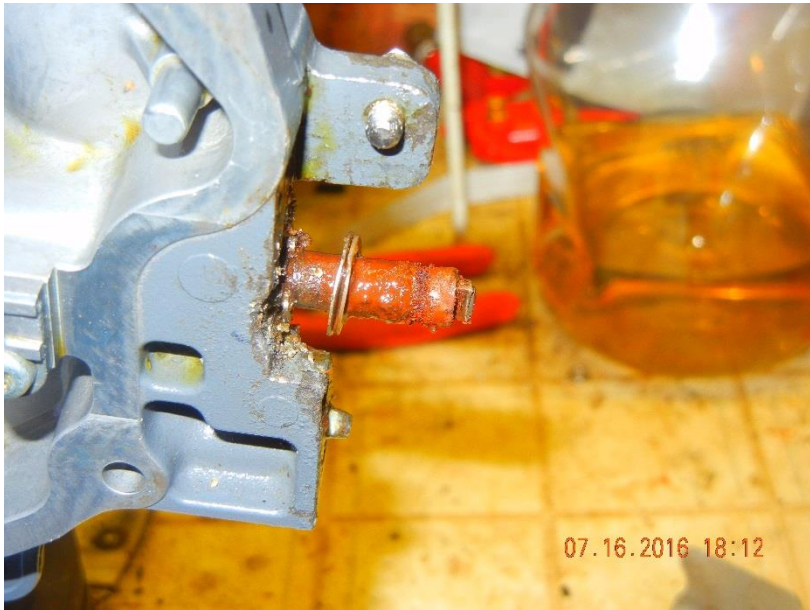
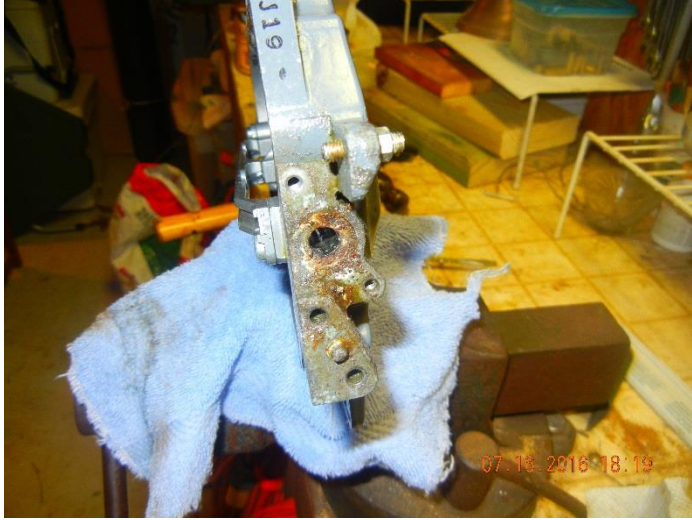
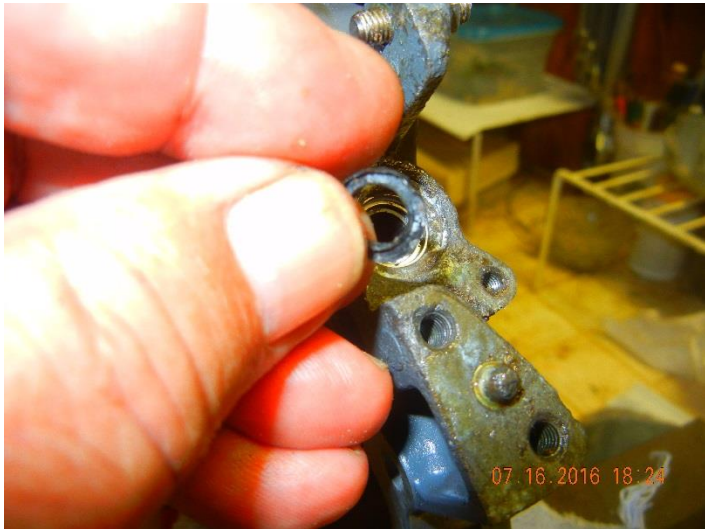
I had to replace the Intake Air Bypass (IAB) on my BF 225. So I disassembled the old one to see why it failed. The short answer is salt water corrosion in one difficult-to-access location. See below.

All of the corrosion will be behind that spring base plate. There is a rubber seal in there that prevents water and crude from getting further up the shaft. Above the rubber seal there is a metal and a nylon washer, all held in place by the half circle clip. I would recommend using a right- angle pick to carefully remove as much corrosion as possible and then use PB blaster and/or WD-40 to clean and lubricate as much as possible. Compressed air will also be helpful in cleaning it out. Work the shaft back and forth to the point where it is relatively easy to move by hand. It will still be a bit tight, by design, but if you can move it with finger strength, then the vacuum diaphragm will also move it. Work at it as long as necessary – remember, you are saving some serious money if you can get it operating correctly.

If you can't move the IAB shaft, or if it does not pop right back in place, then you need to remove the IAB and clean and lubricate the shaft to the IAB bevels. Spend some time with a good penetrating oil like PB Blaster and keep trying to work the shaft to loosen it up. Let it soak in oil overnight. Be careful to not bend or hit the baffle plates inside the IAB.

- First, carefully use a flat blade screwdriver to pop the diaphragm arm off its nylon pivot, remove the diaphragm and set it aside.
- Remove the 10 mm bolts at each end of the frame piece on the back of the engine that the cowlings bolt to. This will allow you to pull down on that frame piece an inch or so in order get to the bottom two bolts of the IAB and remove it.
- Remove the ten 8mm bolts holding the IAB in place

- Grab the loose IAB in one hand and pull back on the cowling frame with the other hand to allow you to pull the IAB up and out.
- Remove the two Phillips head screws holding the base of the spring mechanism in place.
- Use a flat blade scraper to gently separate the base of the spring mechanism from the IAB metal base. It will only move about 1/8th of an inch or so.

Then re-install, reversing the disassembly procedure.
