The Original Engine Cooling Pump Since 1921

17000 Pump Series Technical Guide

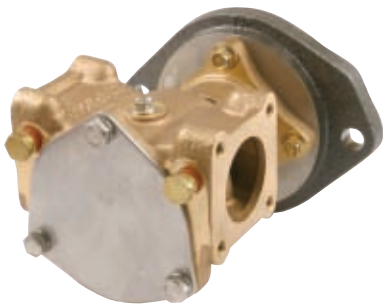
**P1710A, P1710C,
P1710X, P1726X, P1732A,
P1732C, P1732X**

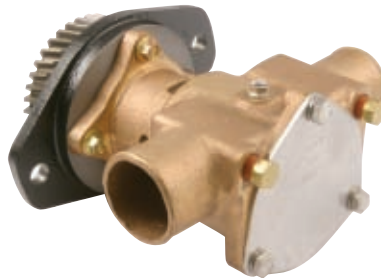
**P1716A, P1716C,
P1716X, P1722A, P1722C,
P1722X, P173**

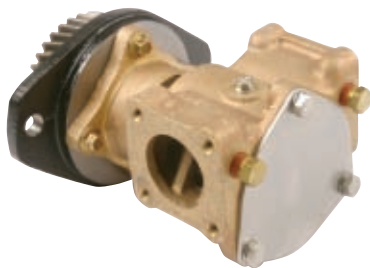
**P1727A, P1727C,
P1727X, P1730A, P1730C,
P1730X, P1731, P1733X**
