Figure 4. MerCruiser Stern Drive Models 888/225-S/233 with Closed Cooling

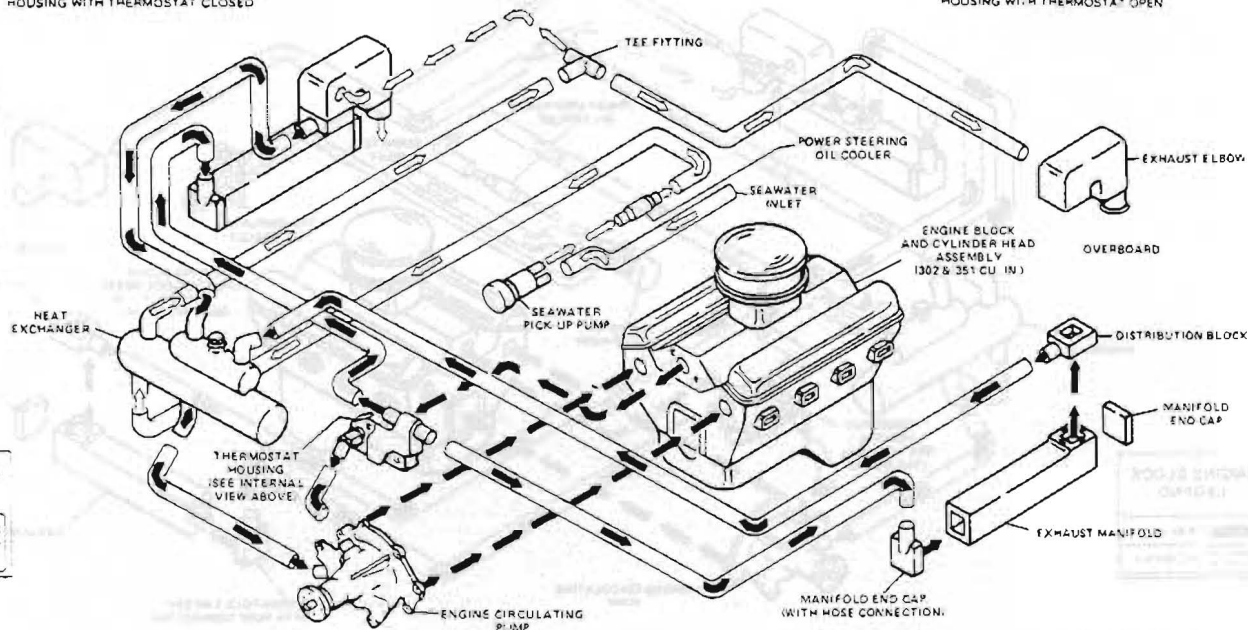
COOLANT FLOW THROUGH THERMOSTAT HOUSING WITH THERMOSTAT CLOSED

COOLANT FLOW THROUGH THERMOSTAT HOUSING WITH THERMOSTAT OPEN
