No. 89-4

## MR and Alpha One Shift Cable Adjustment Inspection and Readjustment

## 813995A2 Shift Assist Assembly Installation

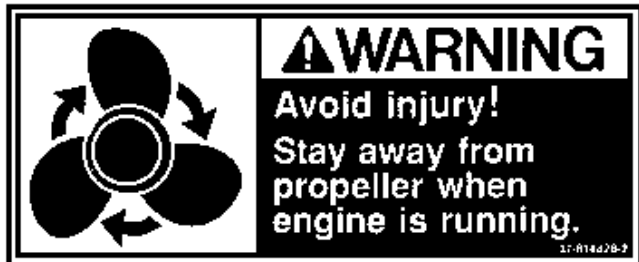
Figure 1.

Two "WARNING" decals (Figure 1) were sent with the letter to the registered owner. One decal is to be put on the dash so it is visible to the operator of the boat. The second decal is to be placed on the transom in a location that is visible to anyone in the vicinity of the propeller.

**SAFE BOATING PRACTICES REQUIRE THAT THE ENGINE BE TURNED OFF WHEN ANYONE IS NEAR THE PROPELLER.** We urge you to do this and instruct other operators of your boat to do so as well. As a reminder of this safe boating practice, enclosed are two decals for your boat; the small one, part number 37-814828-1, for placing in sight at the operator's station and the larger one, part number 37-814828-2, on the transom visible to people in the area of the propeller.

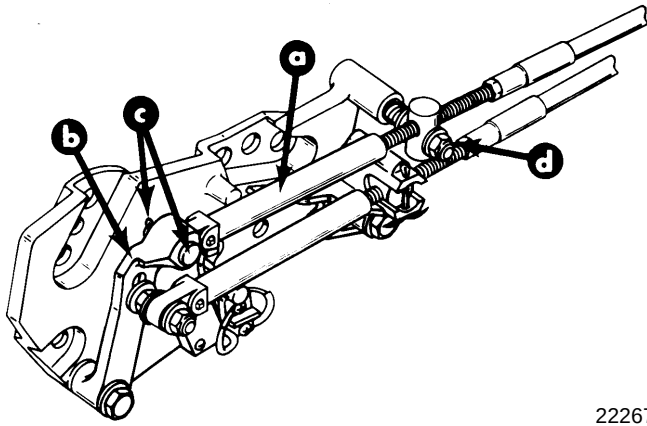
#### Later Models (With Plastic Shift Lever)

3. Disconnect remote control shift cable.

- a - Remote Control Shift Cable
- b - Plastic Shift Lever
- c - Clevis Pin and Cotter Pin
- d - Locknut and Washer

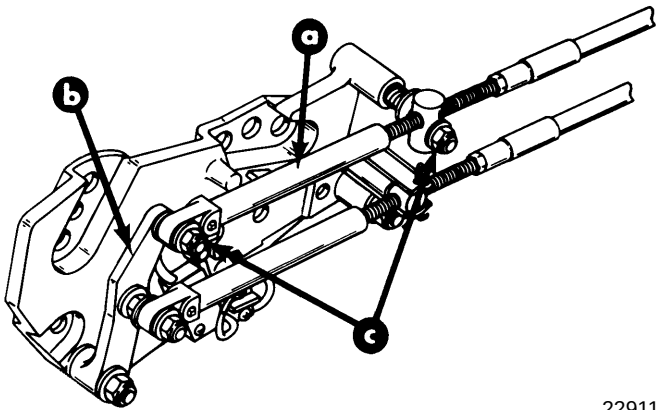
#### Earlier Models (With Metal Shift Lever)

- a - Remote Control Shift Cable
- b - Metal Shift Lever
- c - Locknuts and Washers

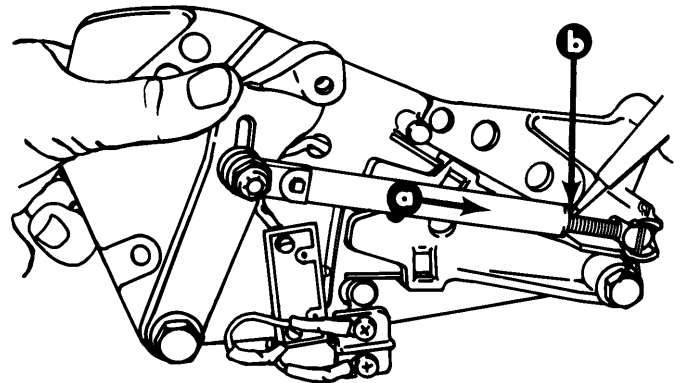
4. Check for excessive play in drive unit shift system as follows:
  - a. Push in on drive unit shift cable to shift into forward gear position.
  - b. Place a mark on shift cable threaded tube, against cable end guide.

- a - Drive Unit Shift Cable
- b - Threaded Tube-Mark "Here"

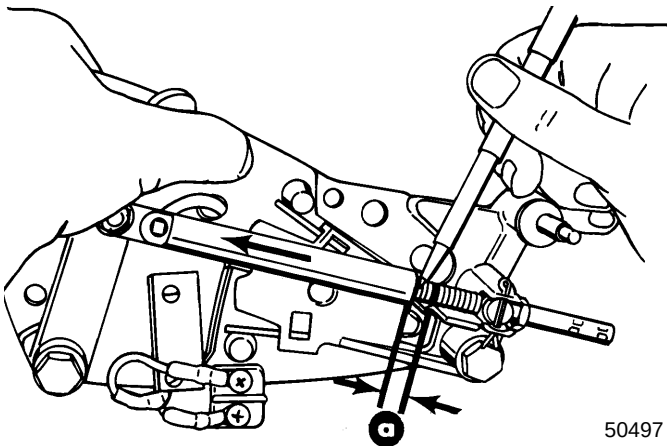
- c. Lightly pull on drive unit shift cable end guide and place another mark on threaded tube.
- d. Measure distance between both marks. Distance should be **9/16 in. (14mm) or less**.

a - 9/16 in. (14mm) or Less

**If play is 9/16 in. (14mm) or less:** No further attention to drive unit is needed. Proceed with adjustments.

**If play is more than 9/16 in. (14mm):** Drive unit must be removed to further isolate excessive play.

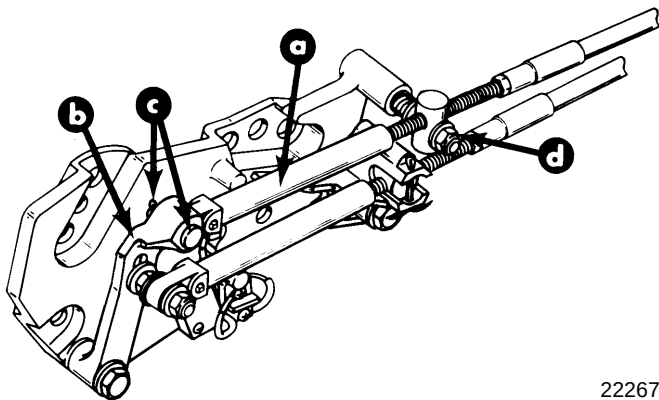
## Later Models (With Plastic Shift Lever)

1. Disconnect remote control shift cable.

- a - Remote Control Shift Cable
- b - Plastic Shift Lever
- c - Clevis Pin and Cotter Pin
- d - Locknut and Washer

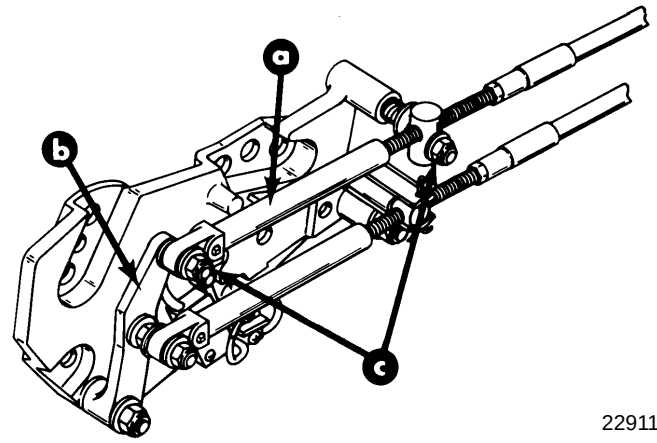
## Earlier Models (With Metal Shift Lever)

- a - Remote Control Shaft Cable
- b - Metal Shift Lever
- c - Locknuts and Washers

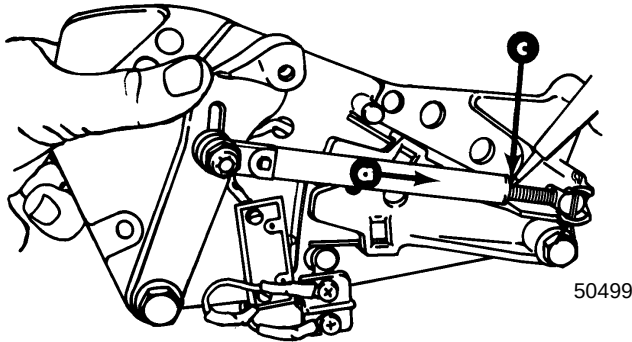
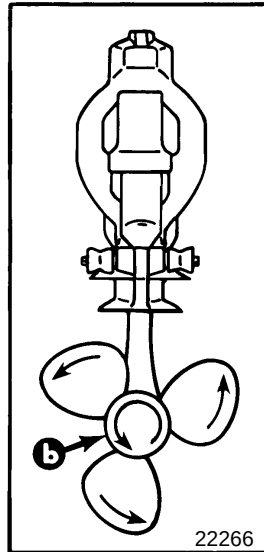
- a. Place drive unit into forward gear by pushing in on drive unit shift cable, while simultaneously rotating propeller shaft counterclockwise until shaft stops, to ensure full clutch engagement.
- b. Place a mark on shift cable threaded tube against edge of end guide.

- a - Drive Unit Shift Cable  
b - Propeller Shaft - Rotate  
c - Threaded Tube - Mark Here

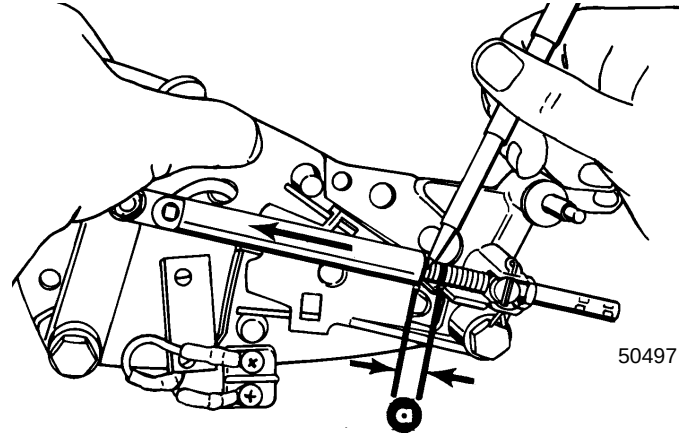
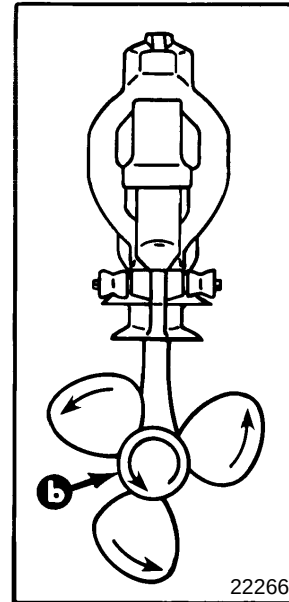
- c. While maintaining pressure on propeller shaft in a counterclockwise direction (to keep clutch locked with forward gear), lightly pull out on drive until shift cable end guide and place another mark on threaded tube.
- d. Measure distance between both marks. Distance should be **9/16 in. (14mm) or less**.

- a - 9/16 in. (14mm) or Less  
b - Propeller Shaft - Maintain Pressure

**If play 9/16 in. (14mm) or less:** No further attention to drive unit is needed. Proceed with adjustments.

**If play is more than 9/16 in. (14mm):** Drive unit must be removed to further isolate excessive play.

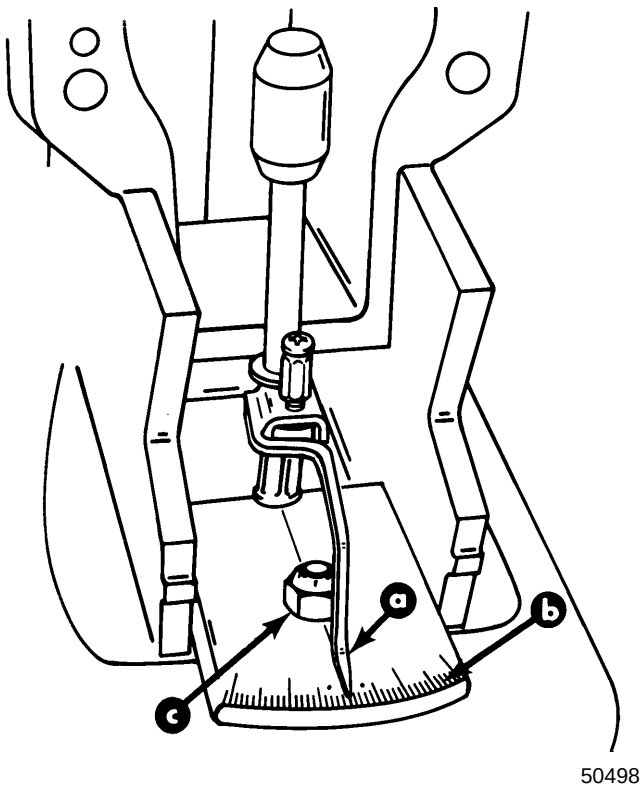
1. To determine shift shaft rotational end play, use a tool such as the one shown, to measure degrees of play in shift shaft, with clutch locked and held in forward gear.

a. Install tool as shown.

- a - Pointer - Installed on Shift Shaft
- b - Scale (1° Increments)
- c - Nut - Hand Tight only

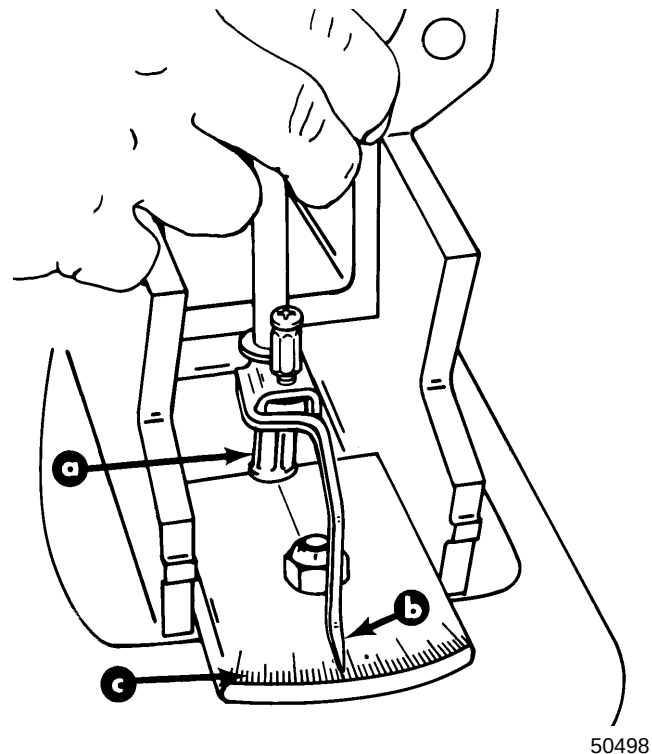
- b. Rotate shift shaft coupler clockwise while simultaneously turning propeller shaft counterclockwise until clutch locks into forward gear. Make note of pointer location on scale.

- a - Shift Shaft Coupler
- b - Pointer
- c - Scale

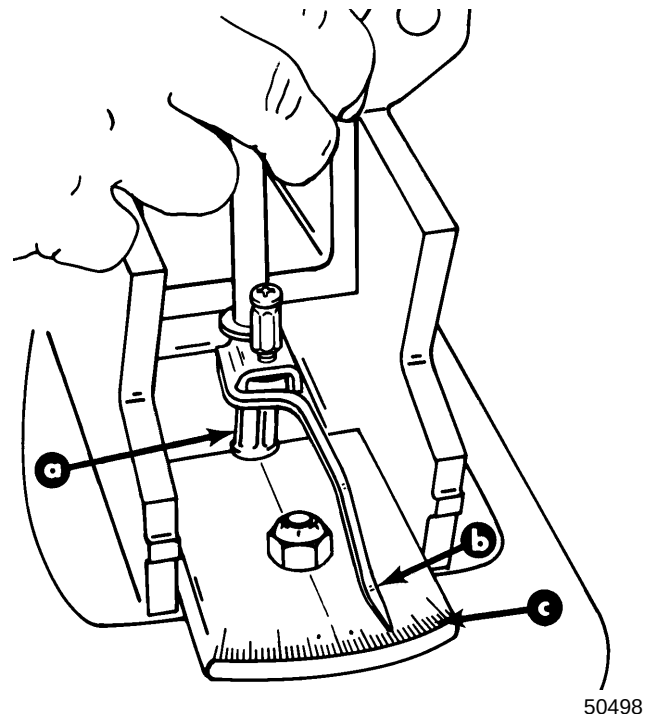
- c. While maintaining pressure on propeller shaft to keep clutch locked with gear, lightly turn shift shaft coupler counterclockwise. Make note of pointer location.

- a - Shift Shaft Coupler
- b - Pointer
- c - Scale

- d. Determine total degrees of movement.

**If 12° or less:** Problem is with the drive unit shift cable, upper shift shaft assembly and lever assembly.

**If more than 12°:** Problem is with gear case shift spool assembly.

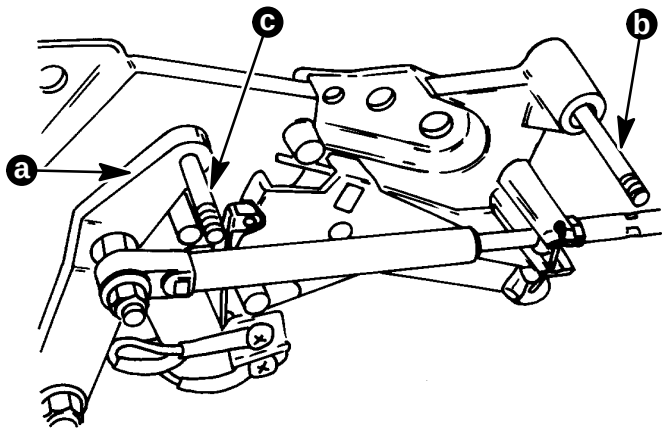
1. Remove short studs from locations shown. Apply Loctite to coarse threads of new longer studs and install as shown. Tighten securely.

- a - Metal Shift Lever
- b - 2-7/8 in. Stud (73mm)
- c - 2-1/8" Stud (54mm)

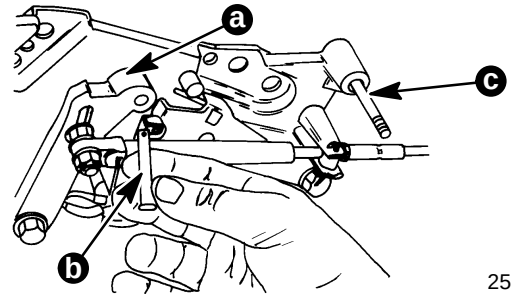
1. Remove and discard short clevis pin. Remove short stud from location shown. Apply Loctite to coarse threads of new longer stud and install as shown. Tighten securely.

- a - Plastic Shift Lever

- b - Longer Clevis Pin

- c - 2-7/8" Stud (73mm)

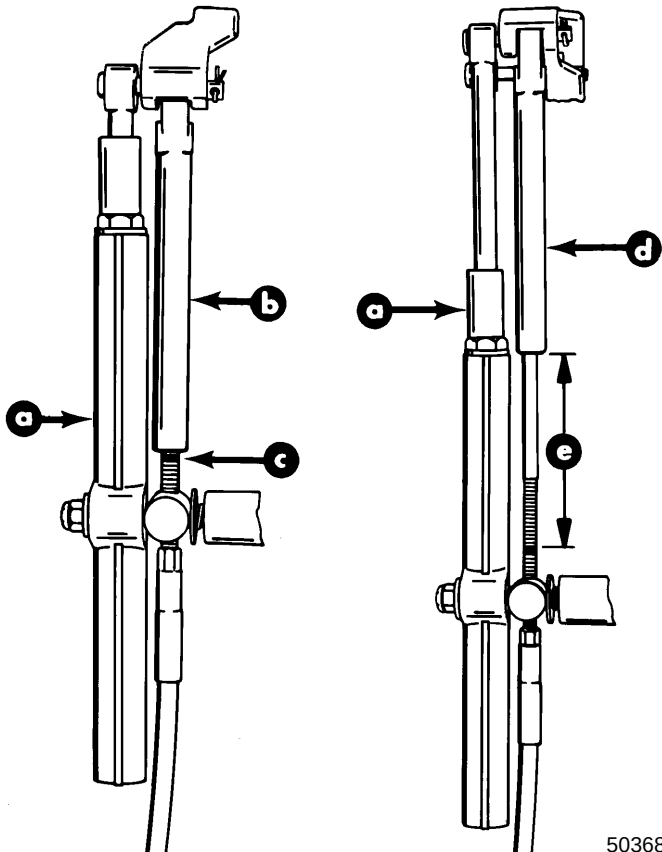
**IMPORTANT:** Remote control must provide a shift cable travel (at the shift plate end) of 2-7/8 in. (73mm) to 3-1/8 in. (80mm) with a 15 – 20 lb.(6.8 – 9 kg) load applied to the cable end guide. This measurement can be taken by installing the remote control shift cable and using the shift assist assembly (provided) to place the proper load of the shift cable (drive unit shift cable should not be installed).

1. Place remote control in forward gear wide open throttle position. Place a mark on threaded tube against edge of cable end guide.

- Place remote control in reverse gear wide open throttle position. Measure the distance between the edge of shift cable end guide and the mark made in step 1. Total shift cable output is not to be less than 2-7/8 in. (73mm) or more than 3-1/8 (80mm). If output is incorrect, remote control and/or shift cable should be replaced.

- a - Shift Assist Assembly
- b - Remote Control Shift Cable - In Forward Gear Position
- c - Place a Mark on Tube Against Edge of Cable End Guide
- d - Remote Control Shift Cable - In Reverse Gear Position
- e - Measurement Taken from Mark to Edge of Cable End Guide: **2-7/8 in. (73mm) to 3-1/8 in.**

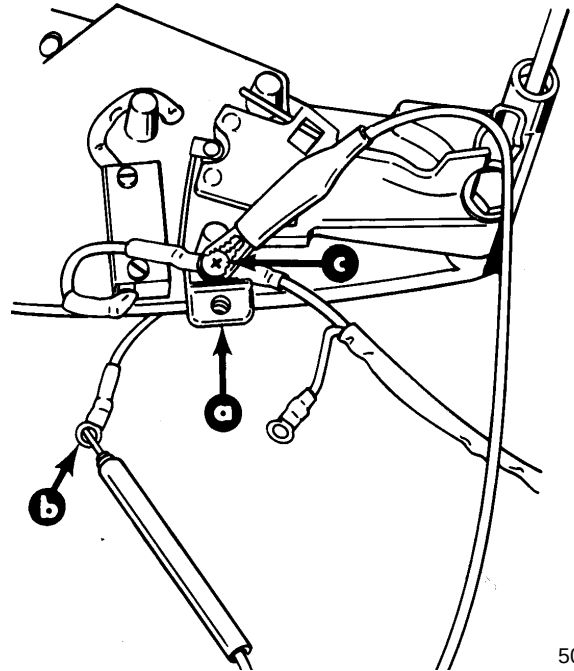
- Disconnect cutout switch white/green wire from terminal block.
- Connect ohmmeter positive (+) lead to cutout switch white/green wire and ohmmeter negative (-) lead to cutout switch black wire at terminal block.
- Set Ohmmeter on RX1 scale.

- a - Terminal Block
- b - Cutout Switch White/Green Wire
- c - Cutout Switch Black Wire

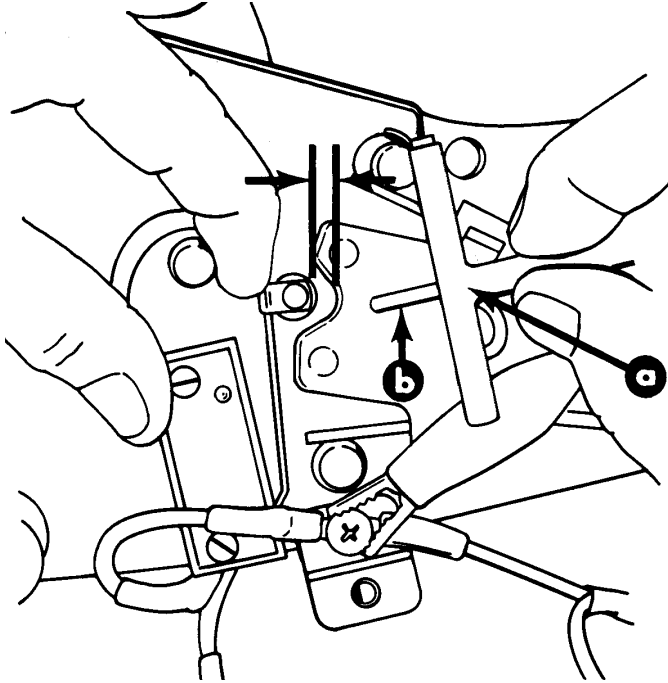
4. Slowly move cutout switch roller off of its seat. Circuit should close (full continuity reading), when roller is moved 1/8 in. (3mm). Use the 1/8 in. rod on the end of special tool to gauge this movement.

- a - Special Tool
- b - 1/8 in. (3mm)

**If switch closes too early (less than 1/8 in.):** Roller must be bent away from its seat.

**If switch closes too late (more than 1/8 in.):** Roller must be bent toward its seat.

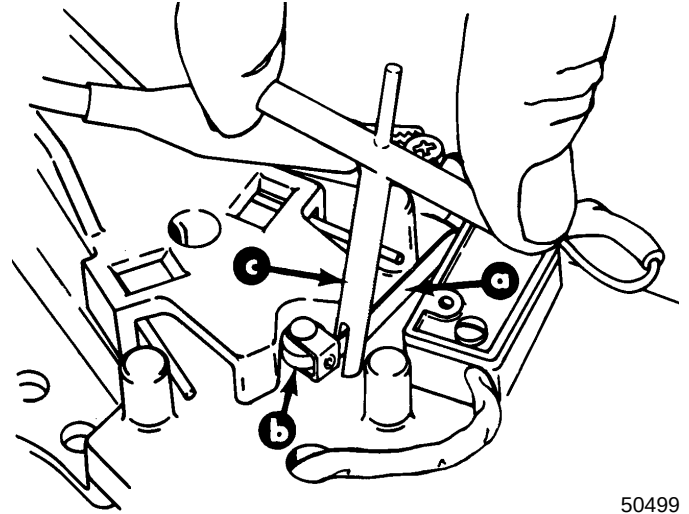
If necessary, use special tool to bend lever as shown.

- a - Lever
- b - Roller
- c - Special Tool

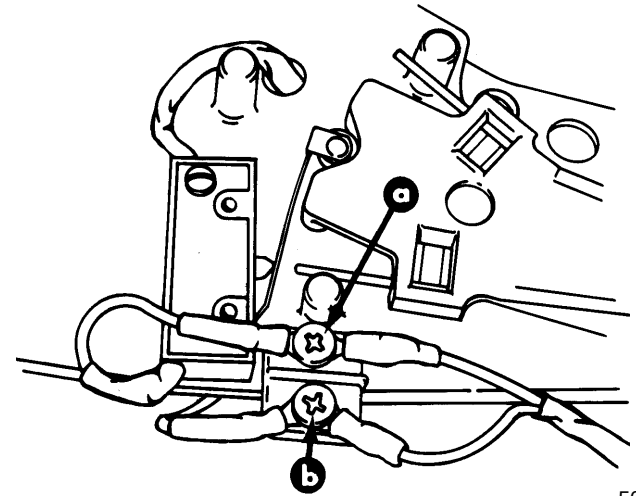
5. Once cutout switch is timed properly, reconnect wires at terminal block and coat terminals with liquid neoprene.

- a - Black Wires
- b - White/Green Wires

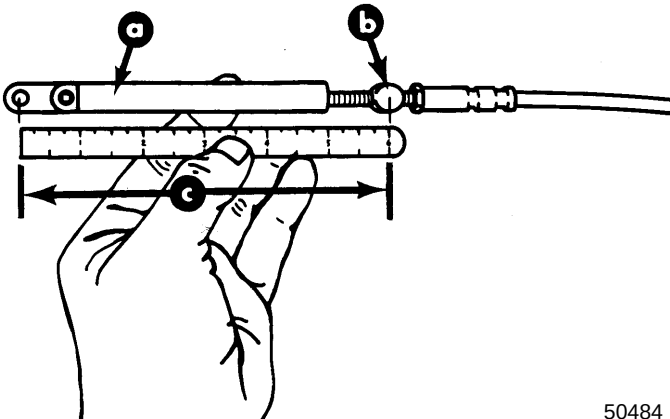
1. Push in on drive unit shift cable while simultaneously turning propeller shaft counterclockwise until shaft stops, to ensure drive unit is completely in forward gear. Maintain pressure on propeller shaft with a suitable device (elastic strap).
2. Measure distance between center of hole in shift cable end guide and center of brass barrel. Measurement should be 6 in. (153mm).

- a - End Guide
- b - Brass Barrel
- c - 6 in. (153mm)

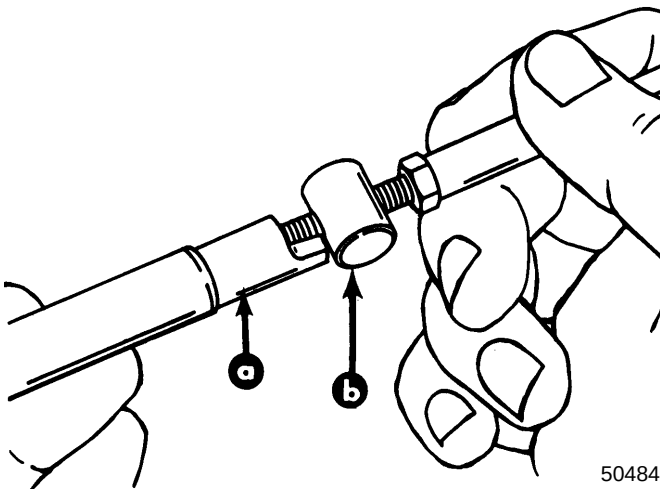
3. Once brass barrel adjustment is correct, install end guide "stop clip" on threaded tube. Position as shown, with tang touching brass barrel.

- a - Stop Clip
- b - Brass Barrel

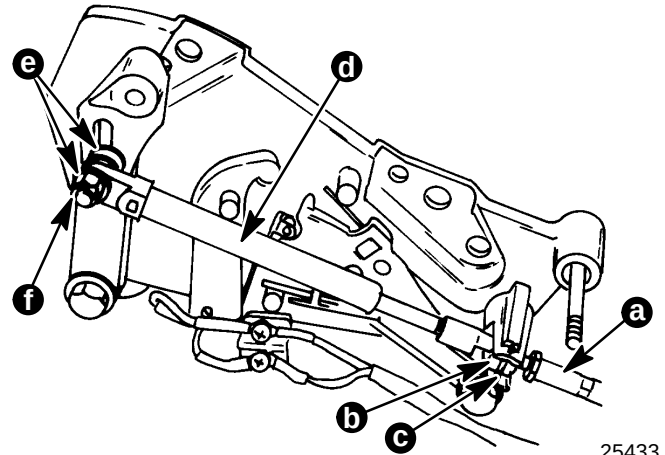
4. Install drive unit shift cable as shown. Secure brass barrel in barrel retainer with cotter pin, spreading both prongs. Secure end guide to shift lever with a washer on each side of end guide and locknut. Tighten locknut until it bottoms, then, back off 1/2 turn.

- a - Drive Unit Shift Cable
- b - Brass Barrel
- c - Cotter Pin
- d - End Guide
- e - Washers
- f - Locknut

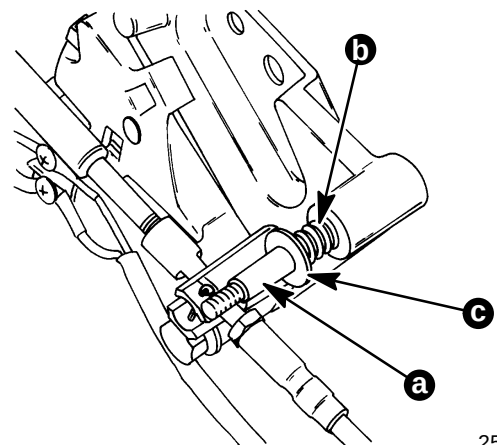
1. Install sleeve, spring and large I.D. washer on stud as shown.

- a - Sleeve
- b - Spring
- c - Large I.D. Washer

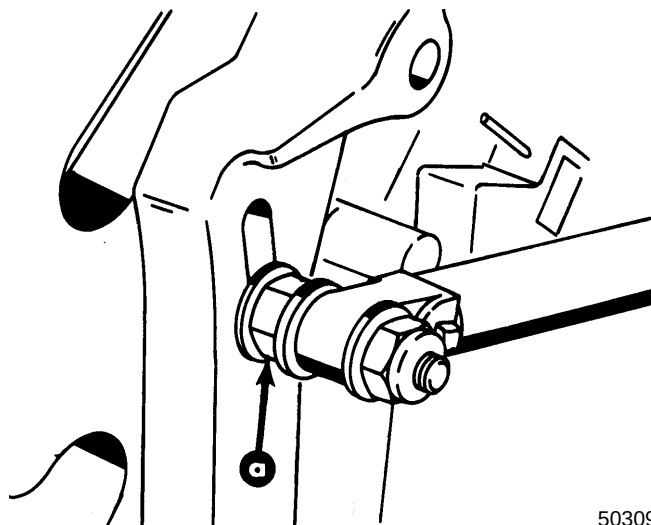
2. Ensure shift lever adjustable stud is at bottom of slot. If necessary, loosen stud and move it to bottom of slot, then retighten stud.

a - Adjustable Stud

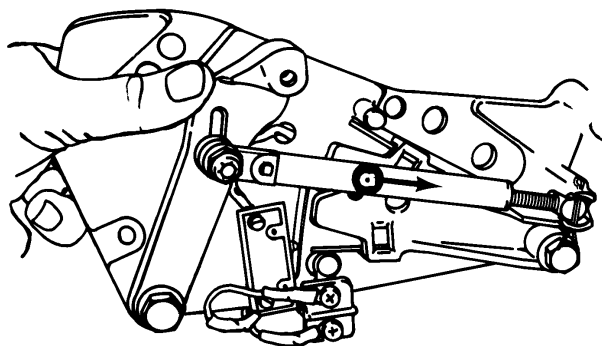
3. Place drive unit into forward gear by pushing in on drive unit shift cable, while simultaneously rotating propeller shaft counterclockwise until shaft stops, to ensure full clutch engagement.

a - Drive Unit Shift Cable - Push In

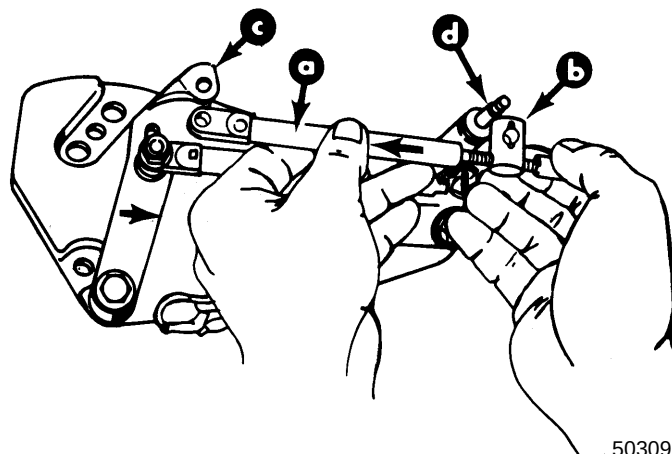
5. Lightly pull on remote control shift cable end guide (to remove slack from remote control and cable) and adjust brass barrel as necessary to align attaching points with shift lever clevis pin hole and stud.

- a - End Guide
- b - Brass Barrel
- c - Shift Lever Clevis Pin Hole
- d - Stud

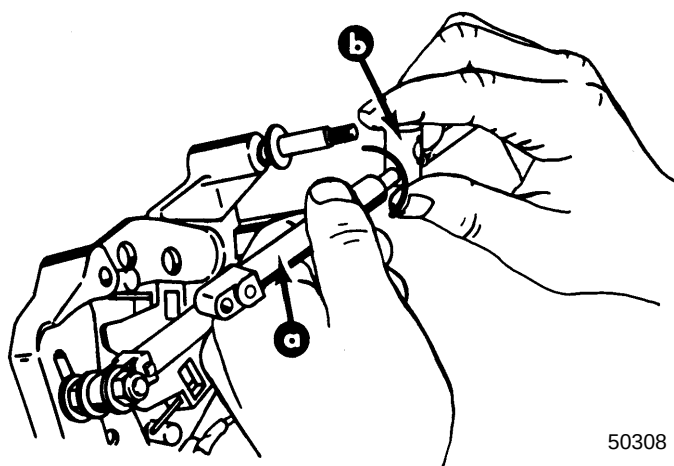
6. After cable has been aligned, turn brass barrel 4 turns **away** from cable end guide.

a - End Guide  
b - Brass Barrel

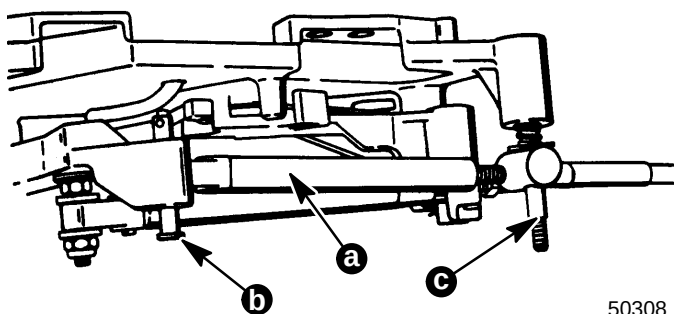
7. Temporarily install remote control shift cable on stud and install clevis pin.

a - Remote Control Shift Cable  
b - Clevis Pin  
c - Stud

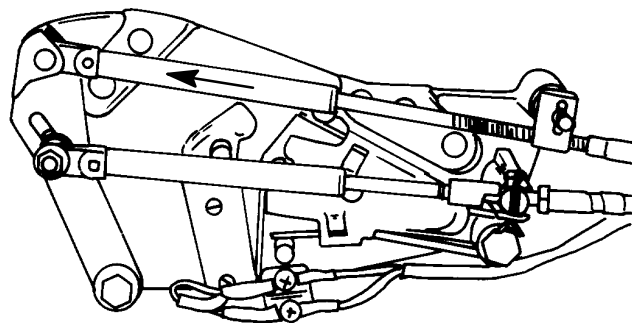
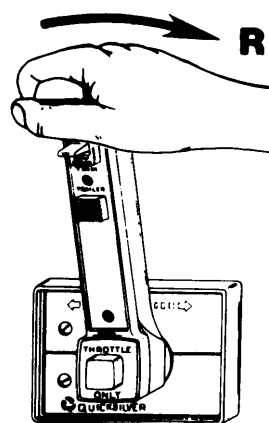
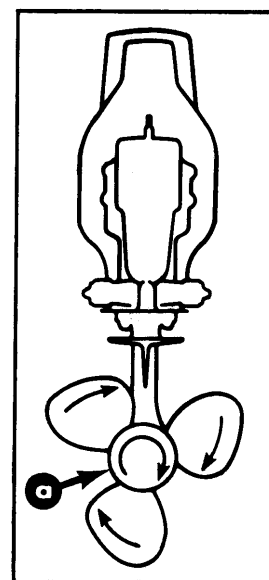
8. Shift remote control into **reverse gear, wide-open-throttle position**, while simultaneously rotating propeller shaft clockwise until shaft stops to ensure full clutch engagement.

a - Propeller Shaft - Rotate Clockwise

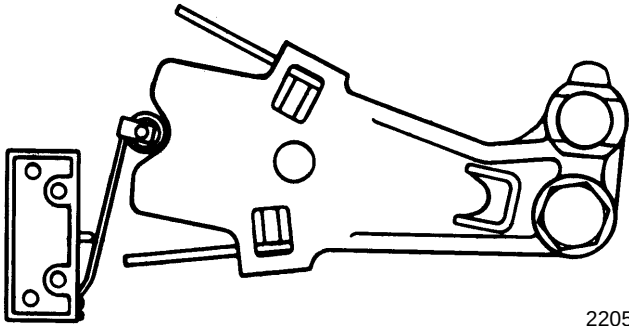
9. Check shift cutout switch lever position. Roller must be centered.

10. If roller is not centered:

- Check to ensure adjustable stud is at bottom of slot in shift lever.
- Check remote control for proper shift cable output (at shift plate) [2-7/8 in. (73mm) to 3-1/8 in. (80mm)].
- If "a" and "b" are correct, check to ensure drive unit shift cable is not crushed or kinked. If drive unit shift cable is binding the shift cutout switch roller will move off center when shifting "into" and "out of" forward and reverse). If cable is binding, replace cable following instructions in stern drive service manual.
- If shift cutout switch roller moves off center when shifting into **reverse only**, drive unit shift cable may not be installed properly at bell housing. Remove stern drive unit and ensure shift cable is installed properly. Refer to stern drive service manual.

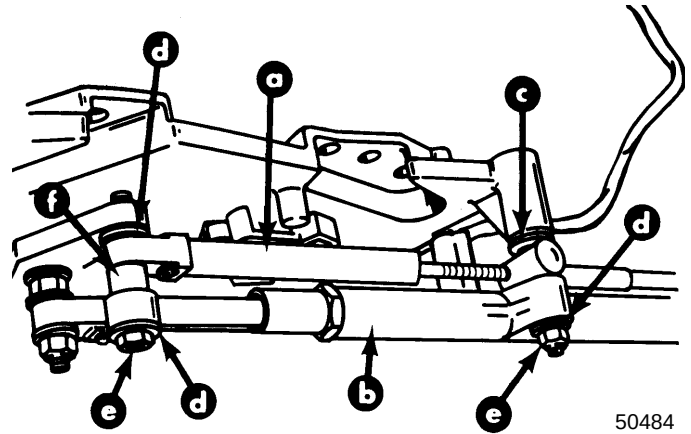
#### Earlier Models (With Metal Shift Lever)

11. After remote control shift plate has been properly adjusted, reinstall cable and shift assist assembly and secure with hardware as shown.

- a - Remote Control Shift Cable  
b - Shift Assist Assembly  
c - Large I.D. Washer  
d - Small I.D. Washer  
e - Locknut - Tighten Until Bottomed then Back off 1/2 Turn  
f - Spacer

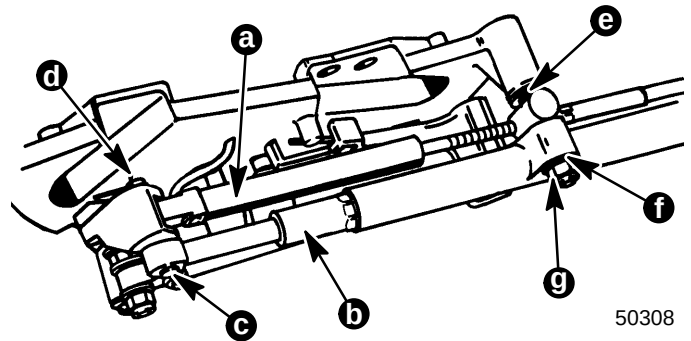
#### Later Models (With Plastic Shift Lever)

- a - Remote Control Shift Cable  
b - Shift Assist Assembly  
c - Clevis Pin  
d - Cotter Pin - Spread both Prongs  
e - Large I.D. Washer  
f - Small I.D. Washer  
g - Locknut - Tighten Until Bottomed then Back off 1/2 Turn

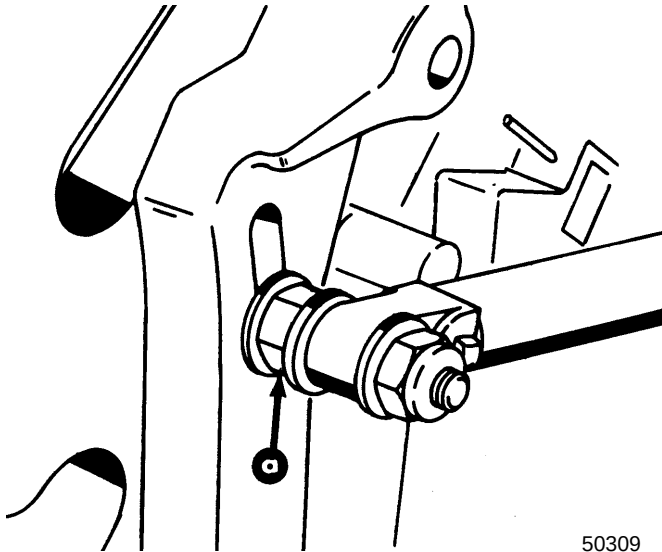
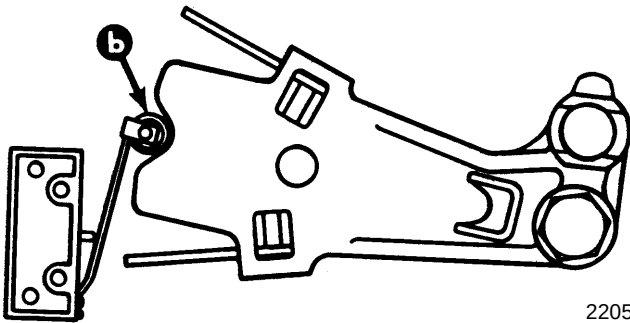
12. Shift remote control into reverse gear, wide open throttle position while simultaneously rotating propeller shaft clockwise. Clutch should engage and cause propeller shaft to lock. If clutch does not engage, loosen adjustable stud on shift lever and move it upward in slot until clutch engages with reverse gear. Retighten stud. Shift remote control several times and stop in reverse to re-check shift cutout switch position. Roller must be centered.

- a - Adjustable Stud  
b - Shift Cutout Switch Roller

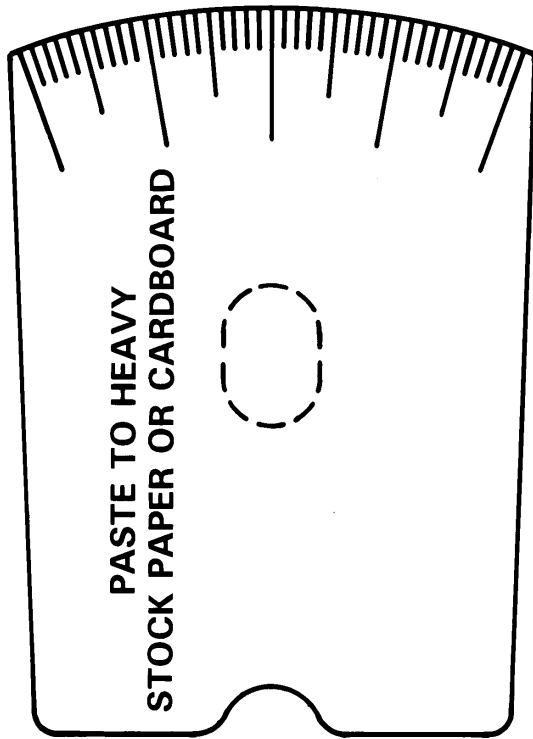
## SCALE

**NOTE:** Tools shown will be available thru Quicksilver at a later date. Refer to the end of this instruction booklet for templates and patterns needed to fabricate similar tools.

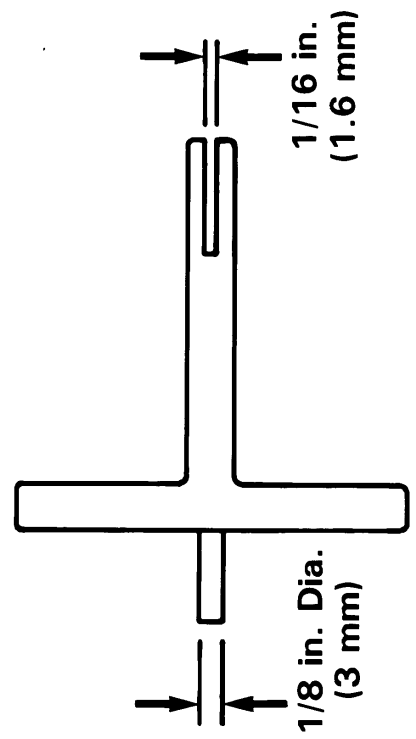
## CUTOUT SWITCH ADJUSTMENT TOOL

**NOTE:** Tool shown will be available thru Quicksilver at a later date. Refer to the end of this instruction booklet for the pattern and dimensions needed to fabricate a similar tool.
